Change of shaftseal on BUUS Iceflakers.

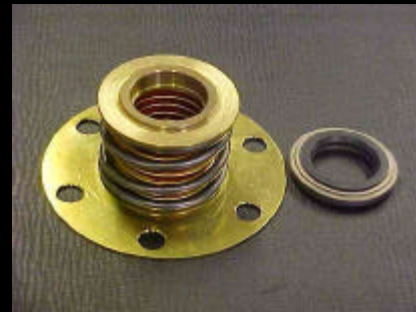
From type 129572

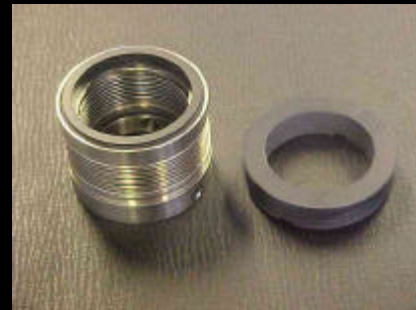
to 011299

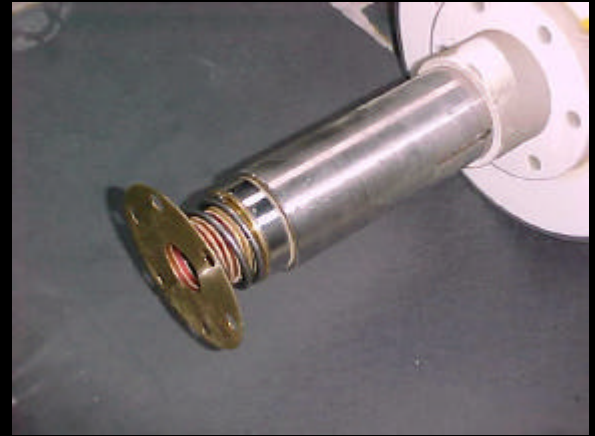
Old type shaft seal

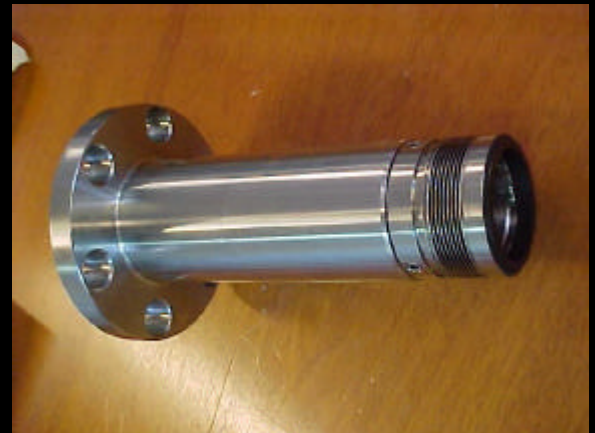
After the repair

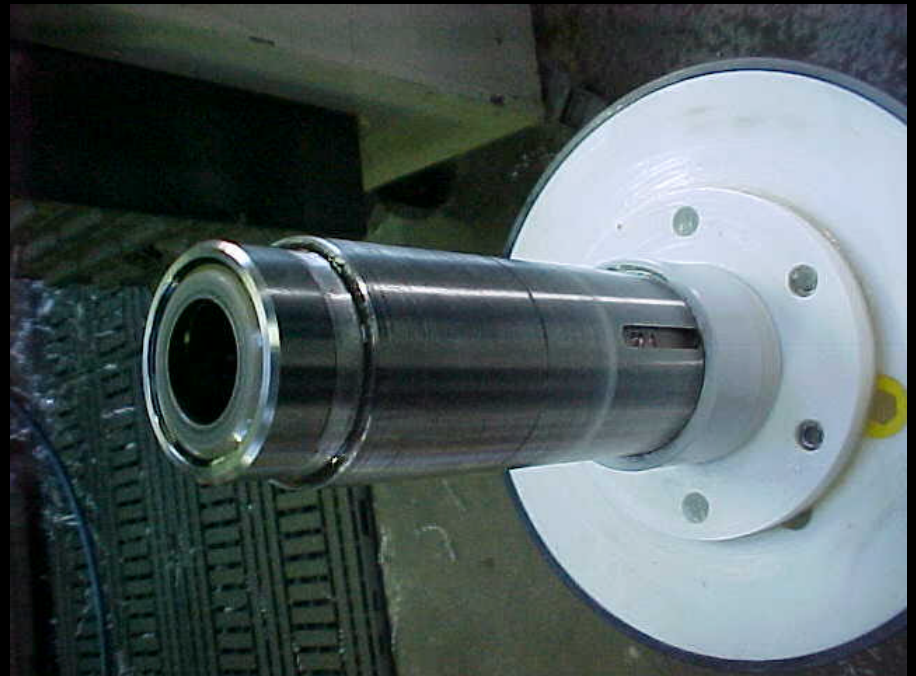
The drum is dismounted

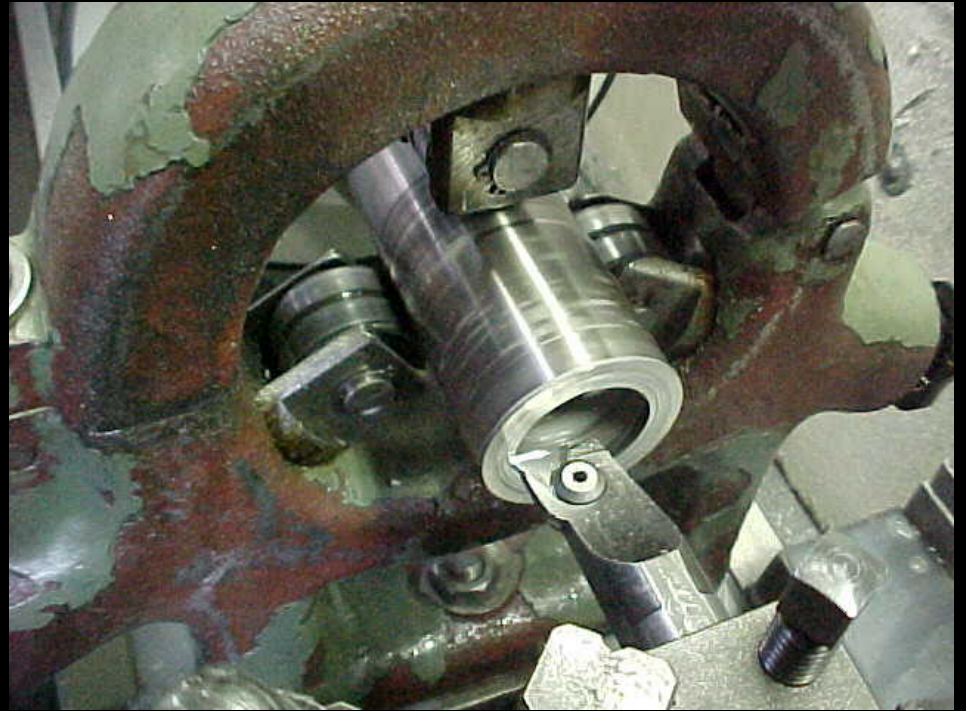
The outer parts of the shafts are removed

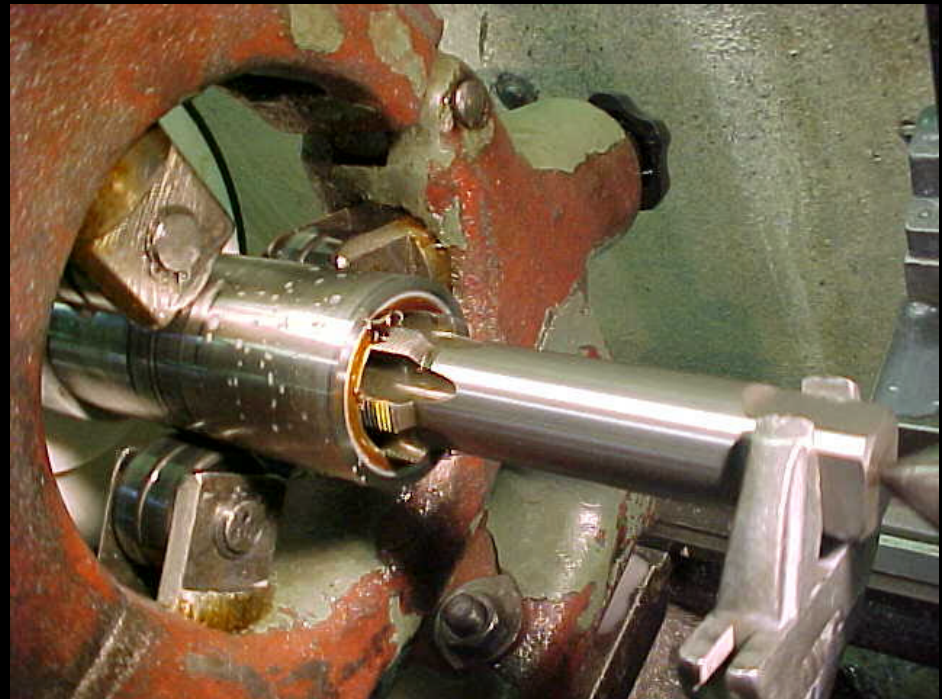
A thread for the adapter
is made

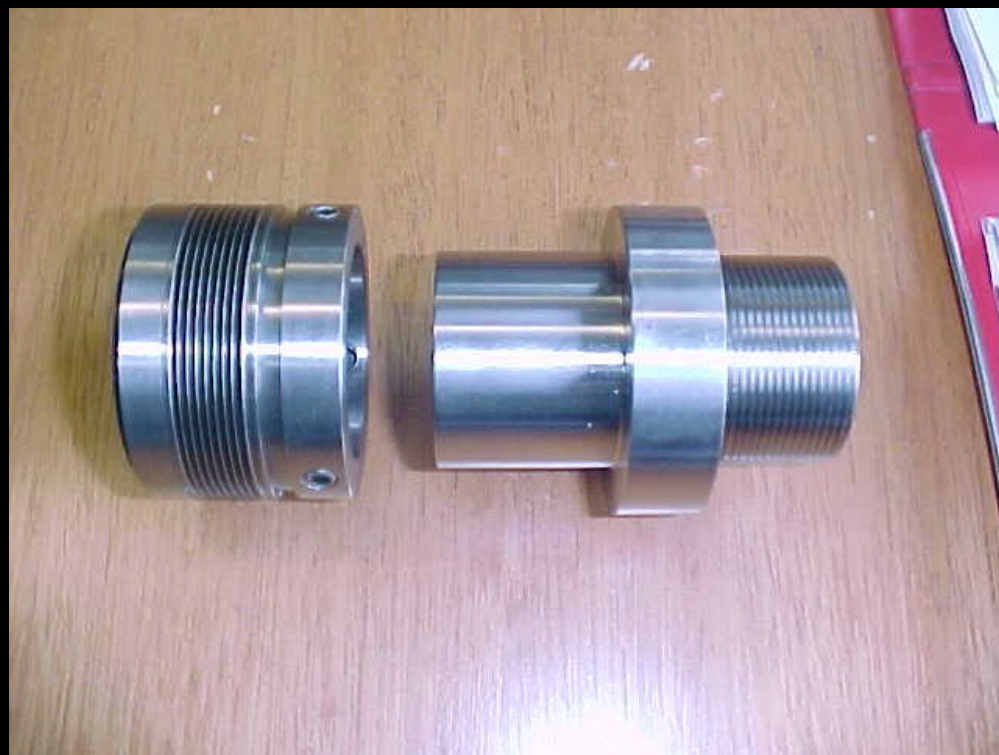
The adapter

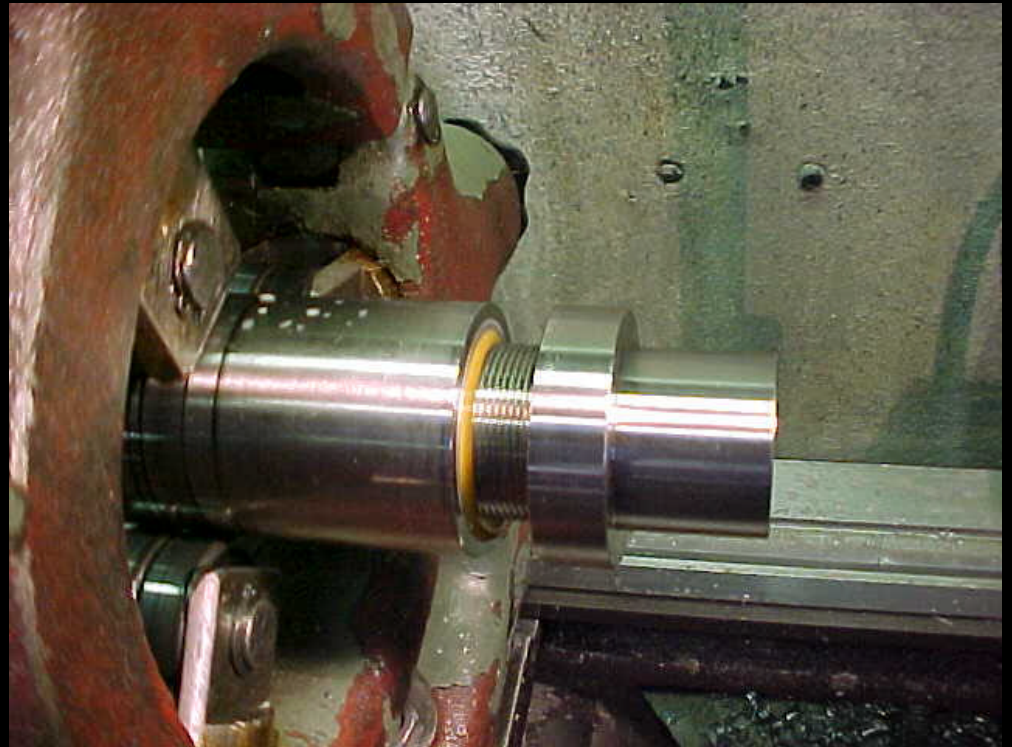
The adapter is mounted

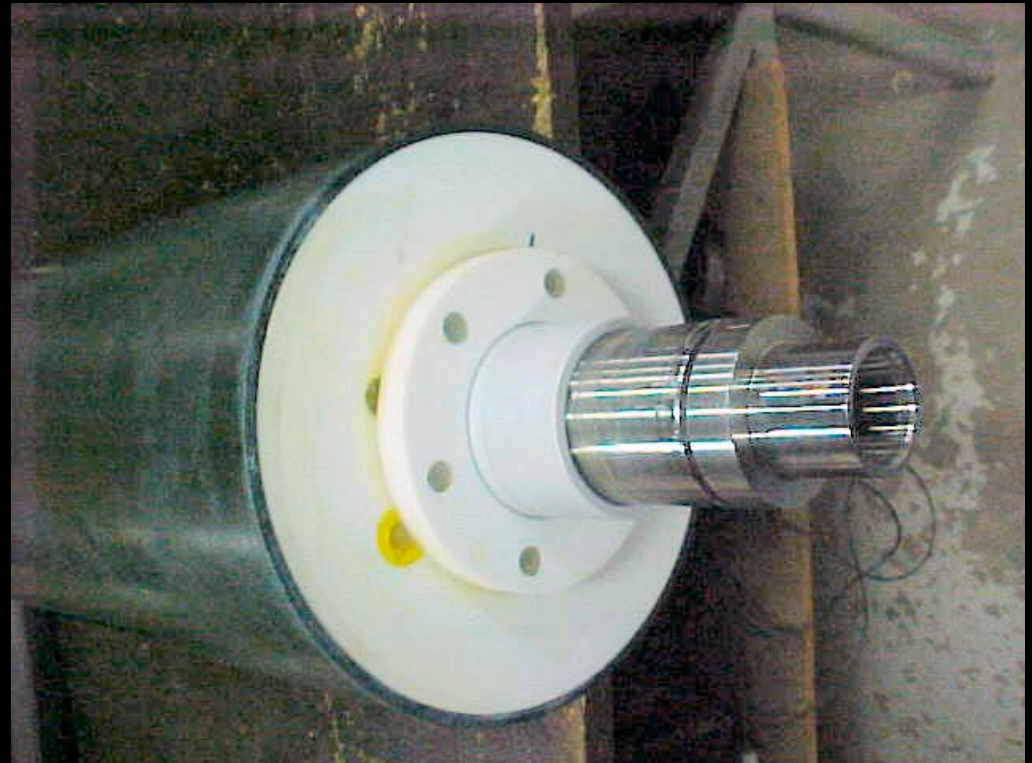
The adapter is mounted
and the drum ready to
be reinstalled

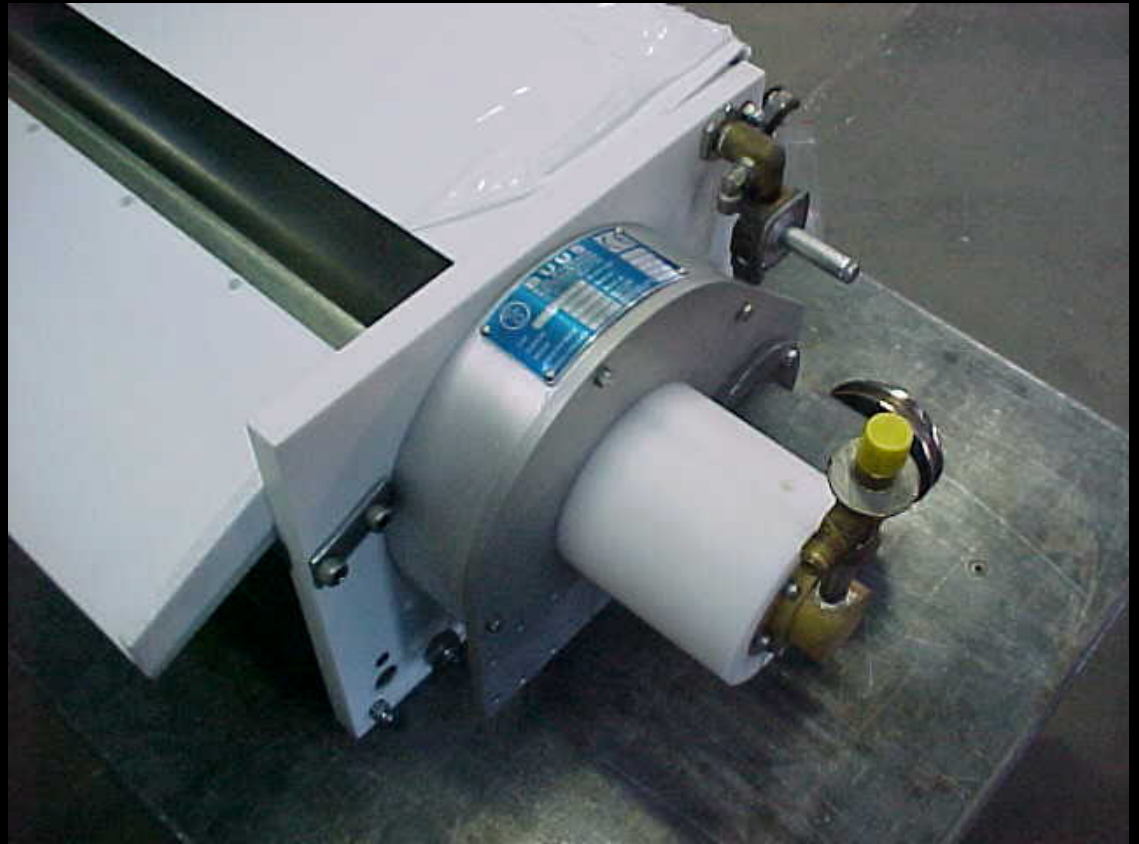
Ready for shipment
